Strengthening peripheral systems to PSA oxygen plant

A case of Sadar Hospital, Samastipur, Bihar, India

Strengthening oxygen systems in the Sadar Hospital, Samastipur

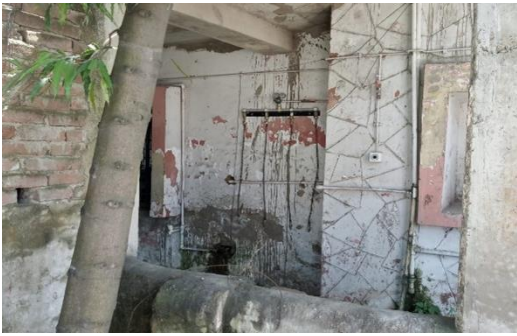
A team of biomedical engineers from PATH alerted the hospital authorities about the need to dismantle all the five smaller manifold rooms. The team explained that the manifold room should have the capacity of at least four cylinders and a copper pipe of at least 2-inch diameter to deliver oxygen at the desired volume and

Figure 1: One of the five old manifolds at Sadar Hospital for two oxygen cylinders

a flow of 4.2–5.5 bar to all oxygen beds and ICU beds in the facility. PATH also provided the hospital authorities with a site location and design for a central manifold room with a medical gas pipeline system (MGPS), which suits the requirement for a 1,000 LPM PSA plant.

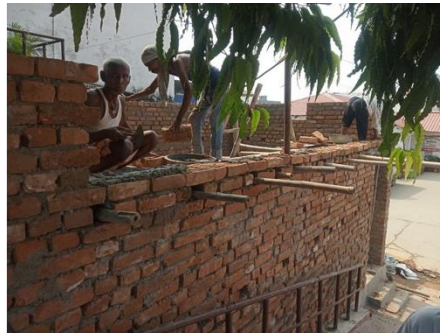
Figure 2: Construction of a central manifold room at Sadar Hospital

The technical advisory was understood and accepted by the hospital officials, and the design, location of the central manifold room, and installation of MGPS were approved. PATH provided technical support to the civil engineering consultants for constructing the central manifold room. Owing to the combined efforts of the PATH team and the hospital administration, the facility now houses a central manifold room with a capacity of eight cylinders that caters to 107 beds supported by a gas pipeline.

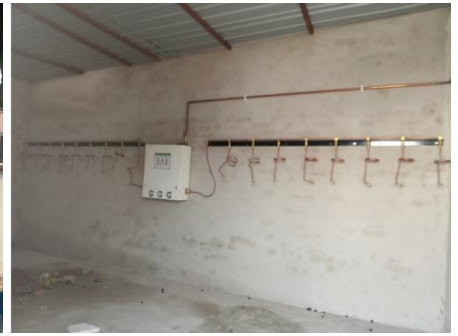
Figure 3: The new central manifold room at Sadar Hospital for eight cylinders

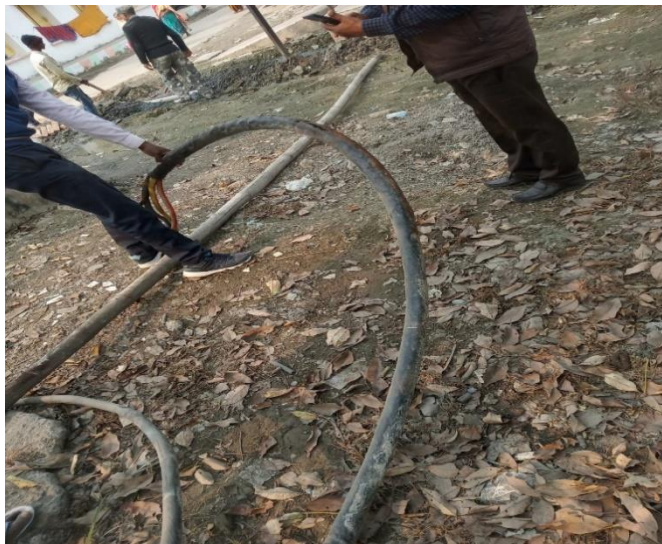
Unit. Following this, the PATH team visited the PSA site at the hospital and found that about 15 meters of the electrical cable attached to the plant was destroyed due to fire. The team deduced that the cause of the fire was a short circuit, which might have been caused for various reasons, such as rainwater getting around the cables, high heat generation, or loose connections between cables.

Figure 4: The electrical cable that got burnt at Sadar Hospital due to a short circuit caused by rainwater

Since the PSA plant was partially handed over to the hospital authorities, PATH had to facilitate a discussion with BMSICL in order to replace the cable. After a series of meetings with the officials and internal approvals, BMSICL replaced the electrical cables. Sadar Hospital's PSA plant is fully functional now and is serving patients who need oxygen support.
